# Service Bulletin

Bulletin No.: PI1002A

**Subject:** Grease or Sealant Visible on Steering Gear – Should Not Be Interpreted as Leak

**Models:** 2014 Chevrolet Silverado 1500  
2014 GMC Sierra 1500

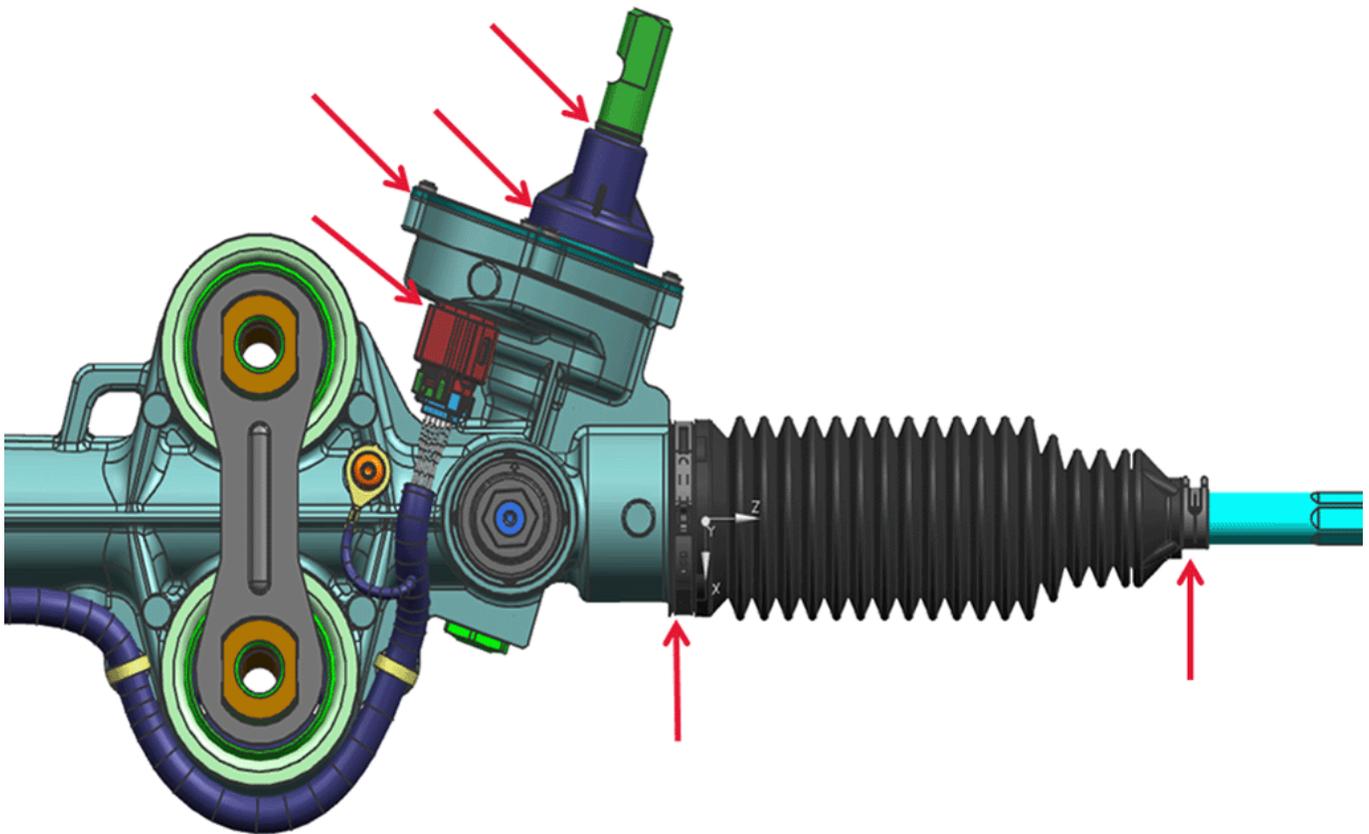
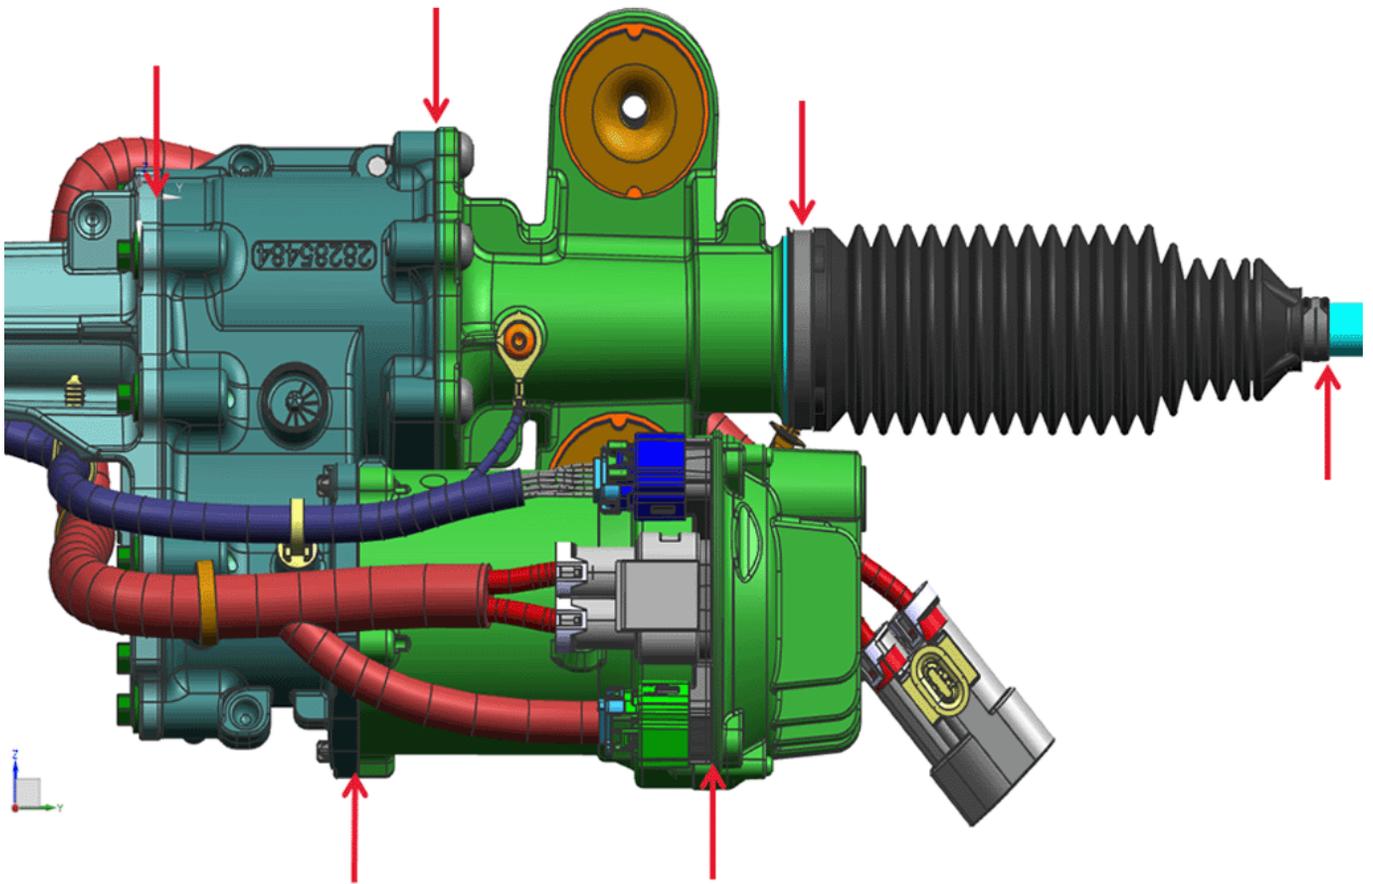
3634928

Some customers or technicians may comment on seeing grease or sealant on certain locations of the steering gear. The illustrations below include arrows showing the areas on the steering gear that the supplier intentionally applies sealing grease. Any of these locations have the potential of showing visible grease under normal operation.

If upon inspection, the steering gear assembly clamps, boots, and fasteners are all in place, the visual evidence of grease/sealant on the exterior of the steering gear is considered normal and **no correction** is necessary. If excess grease is noted, it should be wiped off the exterior of the gear, **however**, sealant should be left in place as a barrier to water and contamination, and no cleaning is required.

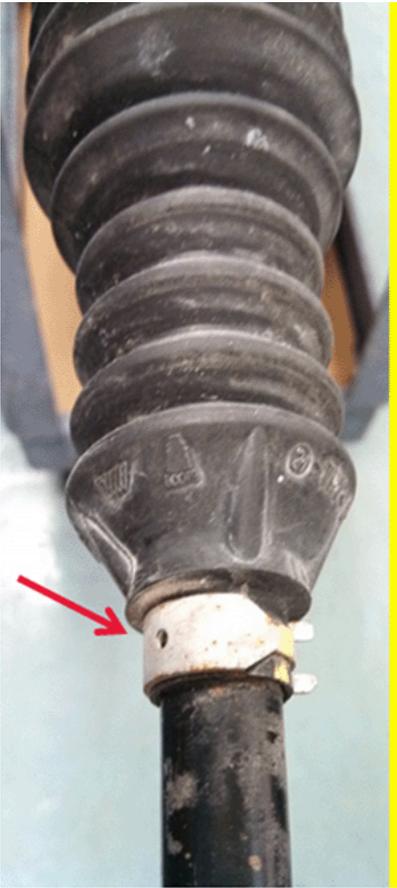
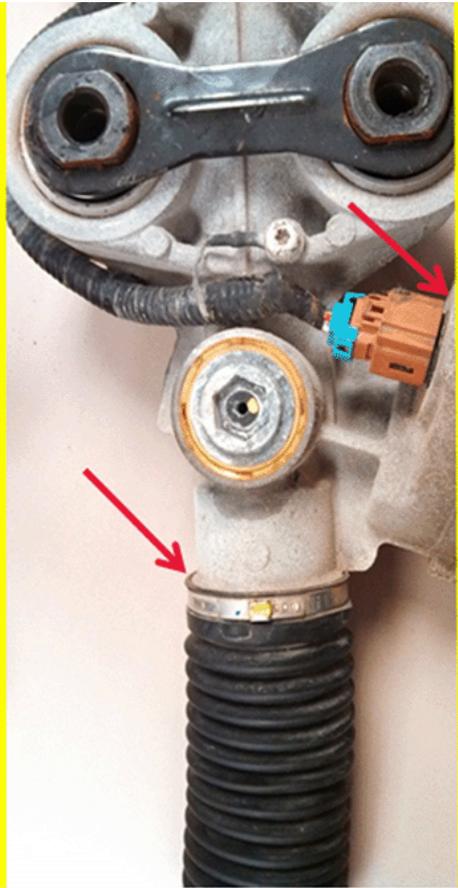
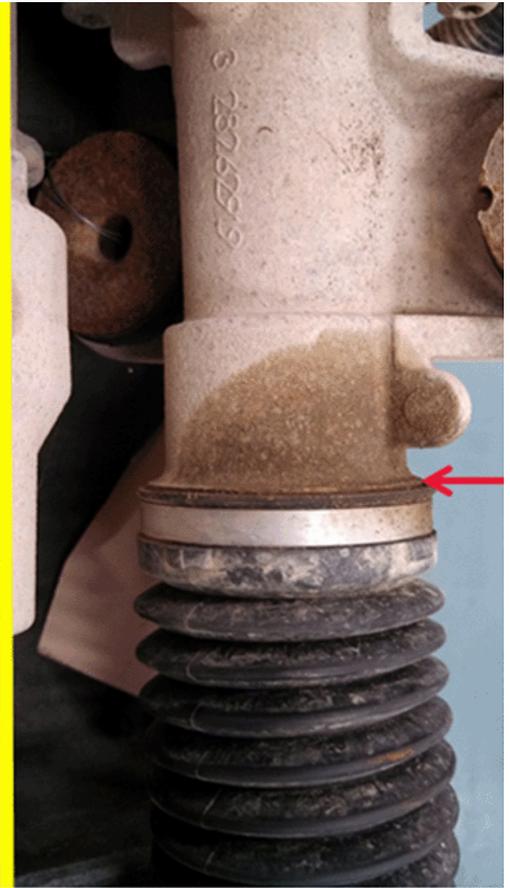
3634935

The graphics below are photo examples, which include arrows showing some of the common areas where grease may be evident after the vehicle has been driven for a length of time.
